## retail feature

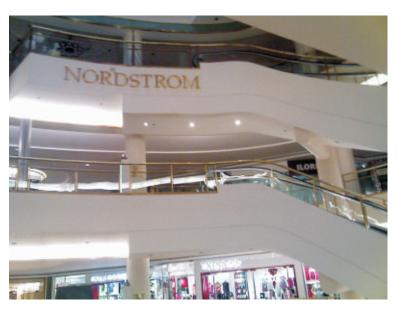
Spiral escalators were first installed by Mitsubishi in 1985 at the Tsukuba Shopping Centre in Japan. Since then there have been only 80 similar units installed worldwide. (Information provided by Mitsubishi,

USA as per a recent article published in Elevator World India puts the figure at over 500, in any case it a miniscule fraction of the total escalators installed globally) Costs are a major discouraging factor. The current estimated cost of each of the spiral escalators (as per Mitsubishi) at the San Francisco Centre is US\$ 1.8 million (over INR 7.5 crores against INR 30 lakhs for a similar straight escalator)

It had taken 15 Mitsubishi engineers over 21/2 years to complete the design of the escalators for the San Francisco Shopping Centre. Precise alignments are key to any escalator installation and operation and becomes an even bigger challenge when the escalators are curved with

no straight lines available for alignment. The truss was shipped to site in seven sections and took nine months to assemble, install and commission. The dome of the mall was left open till the completion of the hoisting work. Interestingly the lady who maintains the escalators today was involved with the installation 20 years back. The fact that she is indispensable is obvious from the fact that she hasn't had another assignment since then.

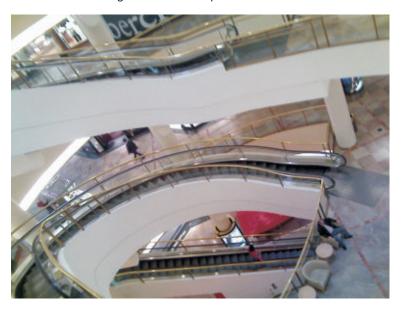
Which bring us back to the question of return on investment. I

am not sure that the spiral escalators at this mall have really contributed to any exponential increase in the revenues of the outlets. I would believe that spiral escalators, unless costs are brought down dramatically, will have to be considered as a style / aesthetic / luxury statement without considering any return on investment. Interestingly one of the store attendants with whom I interacted was a student of architecture on a part time job, who put it in perspective "It is upto the Architect to be creative and not his to worry about the costs or return on investment". Definitely a worrisome thought!
